CAPSULE SUMMARY**CT-394****Lenora Mackey House****6135 Mill Branch Road****Huntingtown, Calvert County****Circa 1895****Private**

Maryland Inventory of Historic Properties Form

Inventory No. CT-394

historic Lenora Mackey House

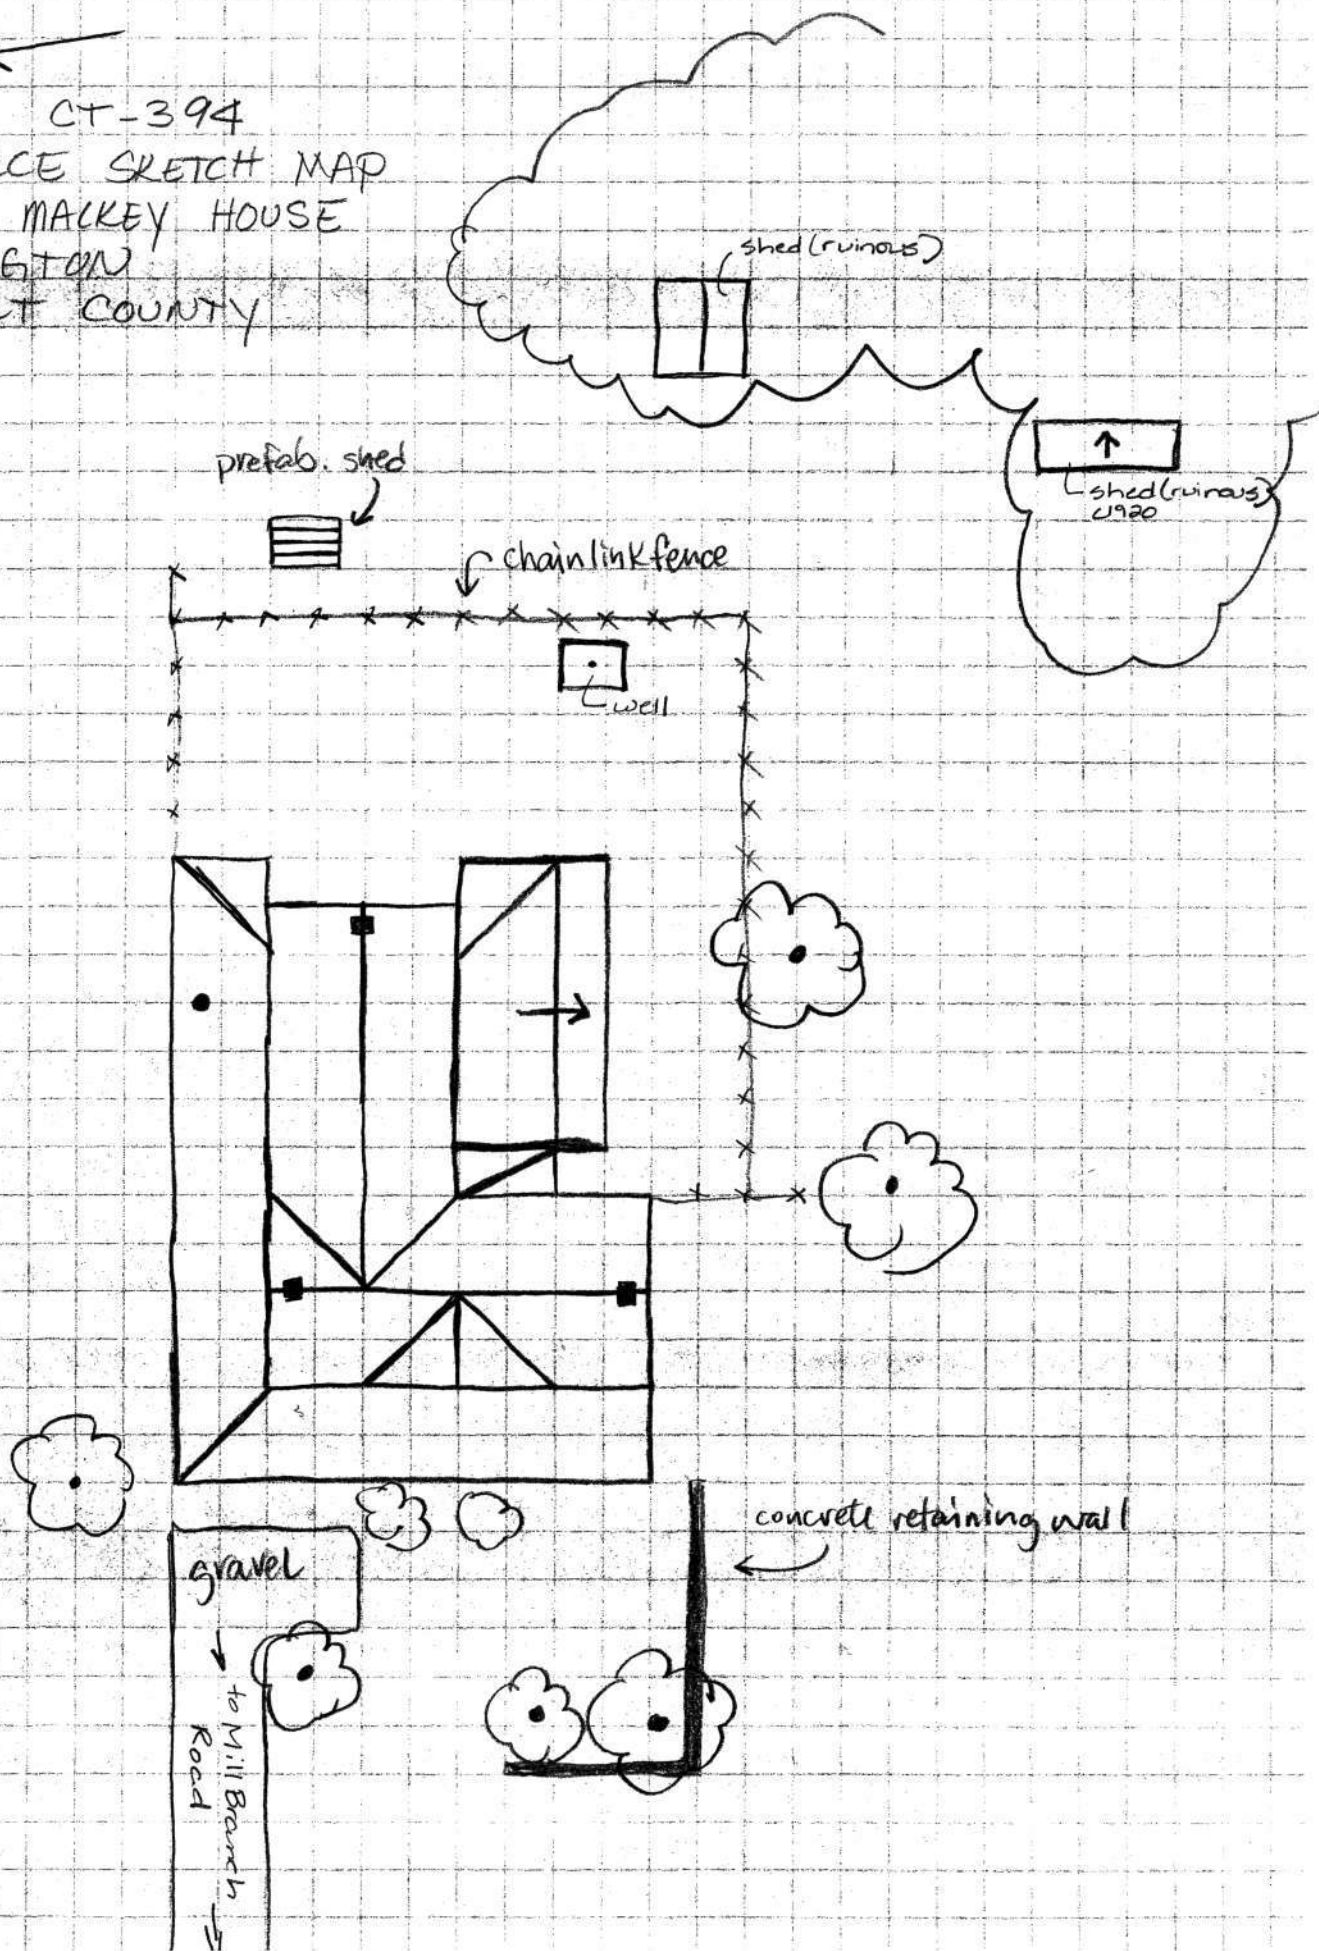
RESOURCE SKETCH MAP
LENORA MACKEY HOUSE
HUNTINGTON
CALVERT COUNTY

SECONDARY RESOURCES. To the east and southeast of the dwelling are several associated buildings and structures. East of the house but within the fenced-in area is a well with a concrete cap, circa 1940, and a metal spicket. Northeast of the well and outside the fence is a one-story, prefabricated, wood-frame shed, circa 1990. The shed is clad in plywood simulating vertical board and has a gambrel roof sheathed in asphalt shingles. Southeast of these buildings and surrounded by trees are two additional one-story, wood-frame outbuildings, both in ruinous condition. These two sheds appear to date to the first half of the 20th century.

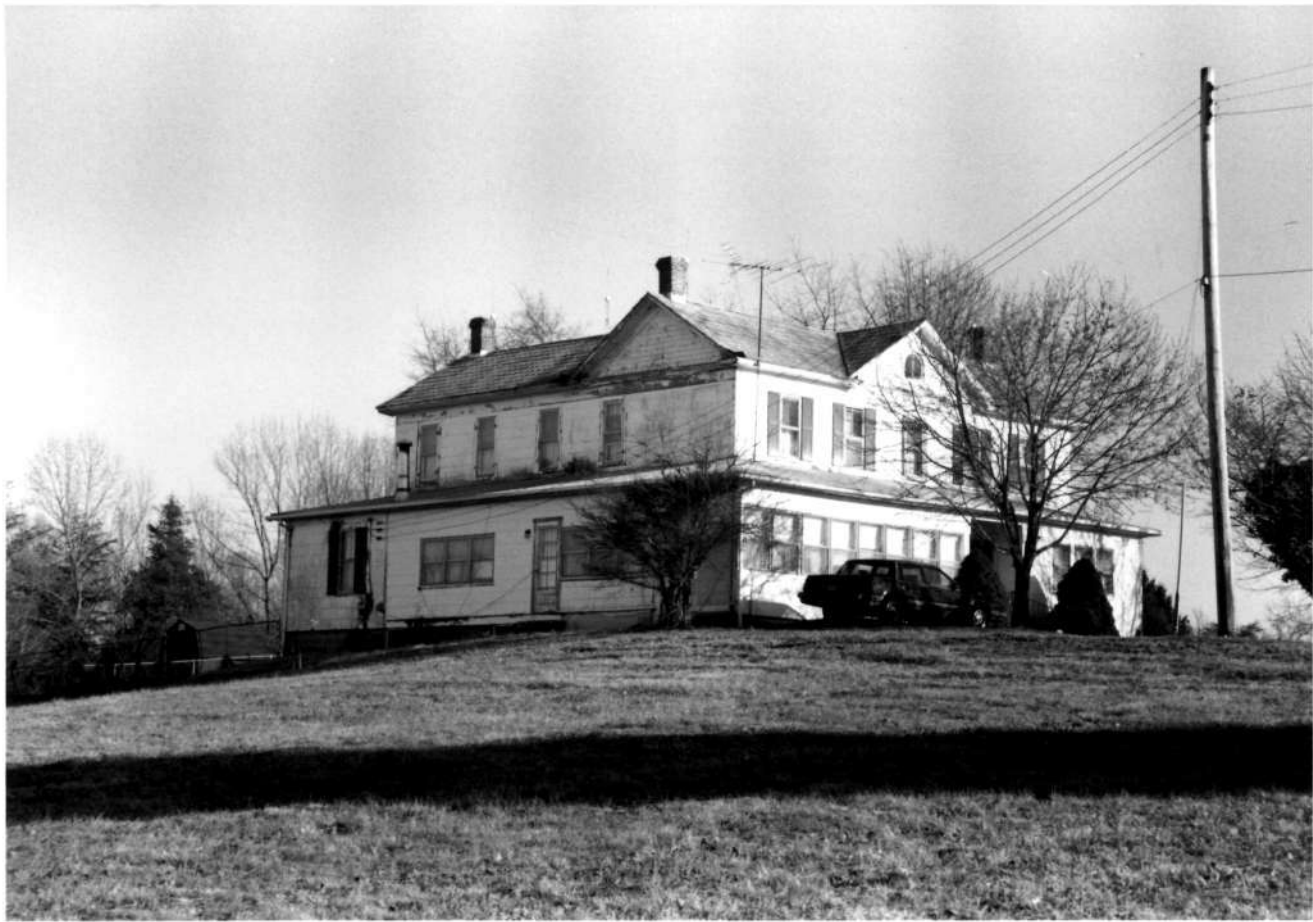
HOUSE, NW CORNER

PRIMARY RESOURCE. The house is a two-story wood-frame dwelling clad in asbestos shingles with a cross-gable roof sheathed in pressed metal shingles. The building rests on a solid concrete-block foundation periodically pierced by three-light windows and has a two-story, rear ell projecting from the rear. The five-bay façade is defined by a central open gable with a two-light, round-arched window and diamond-shaped, wood shingles in the tympanum, 2/2 wood-sash windows flanked by simulated shutters, a molded wood cornice, and an enclosed, one-story, half-hip-roof porch with 1/1 aluminum sash and 2/2 wood-sash windows. The central entry is recessed within the enclosed porch and features a one-light transom and sidelights filled with textured glass dating to the mid-20th century.

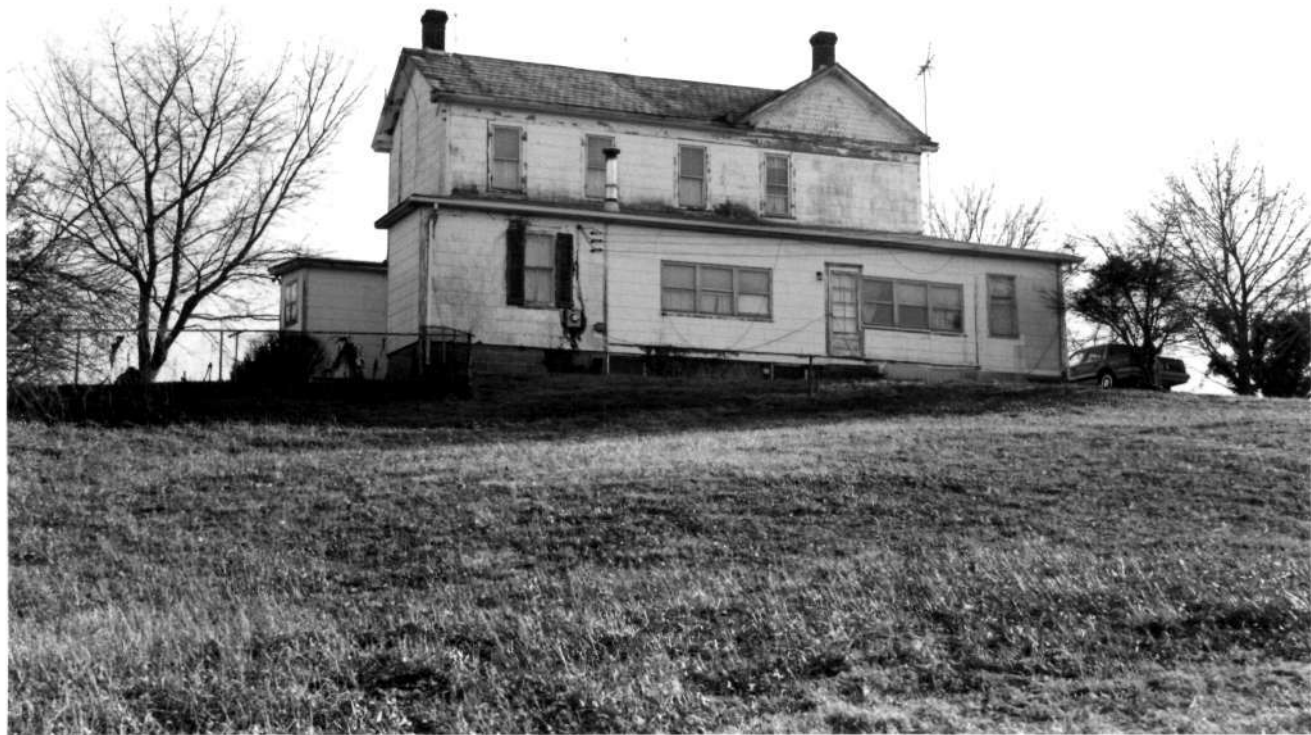
HOUSE, NORTH ELEVATION
2 OF 3

The one-story, enclosed, front porch wraps around the north elevation of the dwelling. At the east end of the porch is a one-story addition with a 2/2 wood-sash window and a solid concrete-block foundation. This addition projects several feet beyond the east elevation of the ell. The south elevation of the ell also features a one-story, enclosed porch with one-story, single-cell addition which projects beyond the east elevation of the ell. Other notable features of the dwelling include projecting closed gables on the side elevations with diamond-shaped wood shingles in the tympanum, brick chimneys with corbeled caps at each of the three gable ends, and a slightly projecting molded wood cornice with a blank frieze.

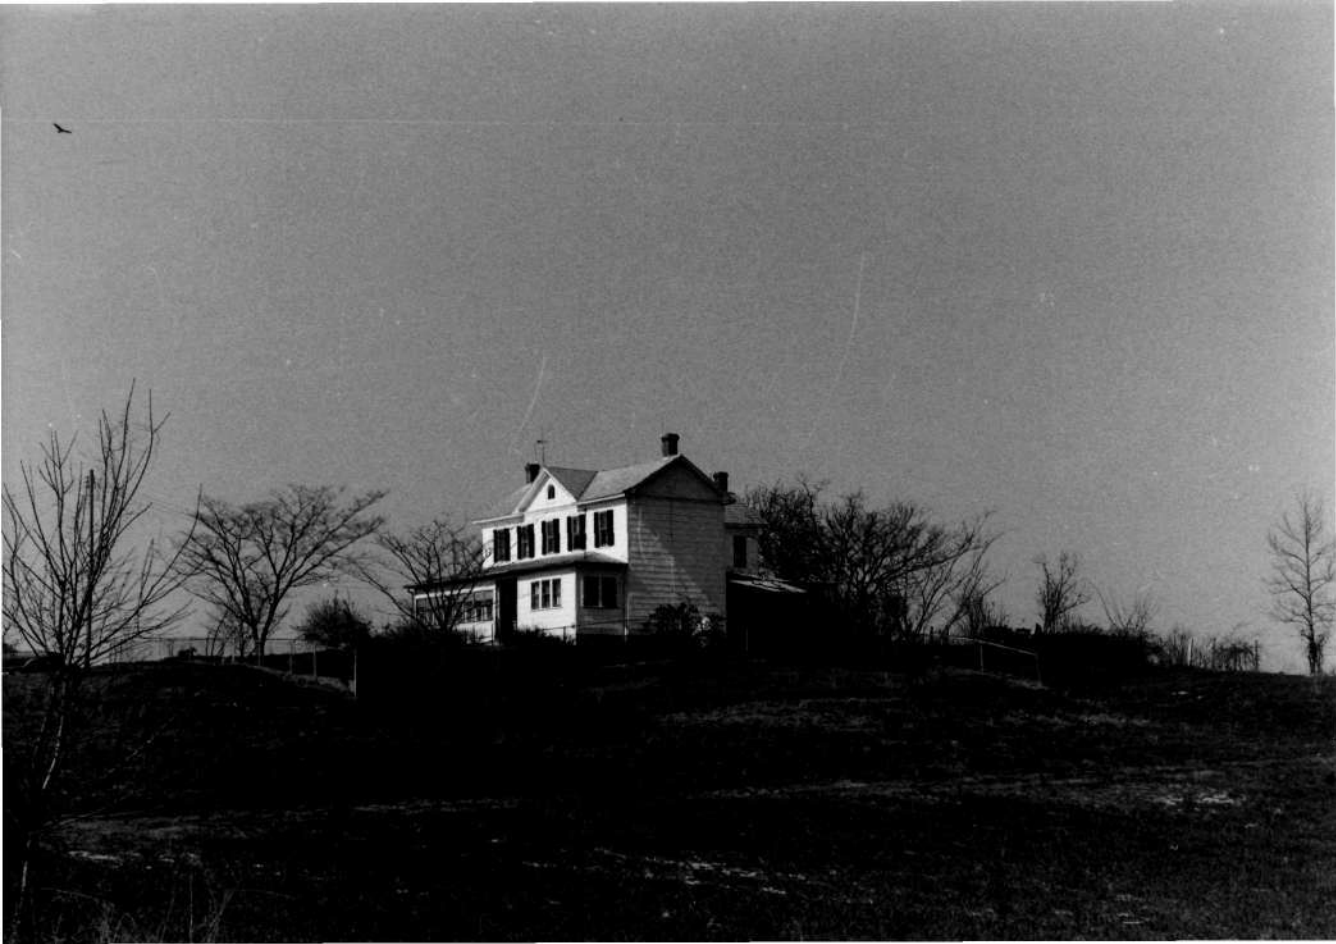
W & S elevation

This two-story frame house measures five bays wide by one bay deep. A prominent cross-gable distinguishes the facade. The gable-roofed house includes a front porch and a rear kitchen section. 2/2 sash windows light the dwelling.

The structure is covered with asbestos shingle siding and has decorative "fish scale shingles" in the gables. Cornice moldings continue across the gables and suggest pent roofs. In the cross gable is a small two light window with an arched top.

Across the entire front elevation is a one story hipped roof porch which has been enclosed, obscuring a view of the original front entrance.

Brick chimneys are located inside the gable walls.
